**THE STREAMBANK EROSION CONTROL  
EVALUATION AND DEMONSTRATION ACT OF 1974  
SECTION 32, PUBLIC LAW 93-251**

## Appendix F - Yazoo River Basin Demonstration Projects

# FINAL REPORT TO CONGRESS

U.S. ARMY CORPS OF ENGINEERS  
December 1981

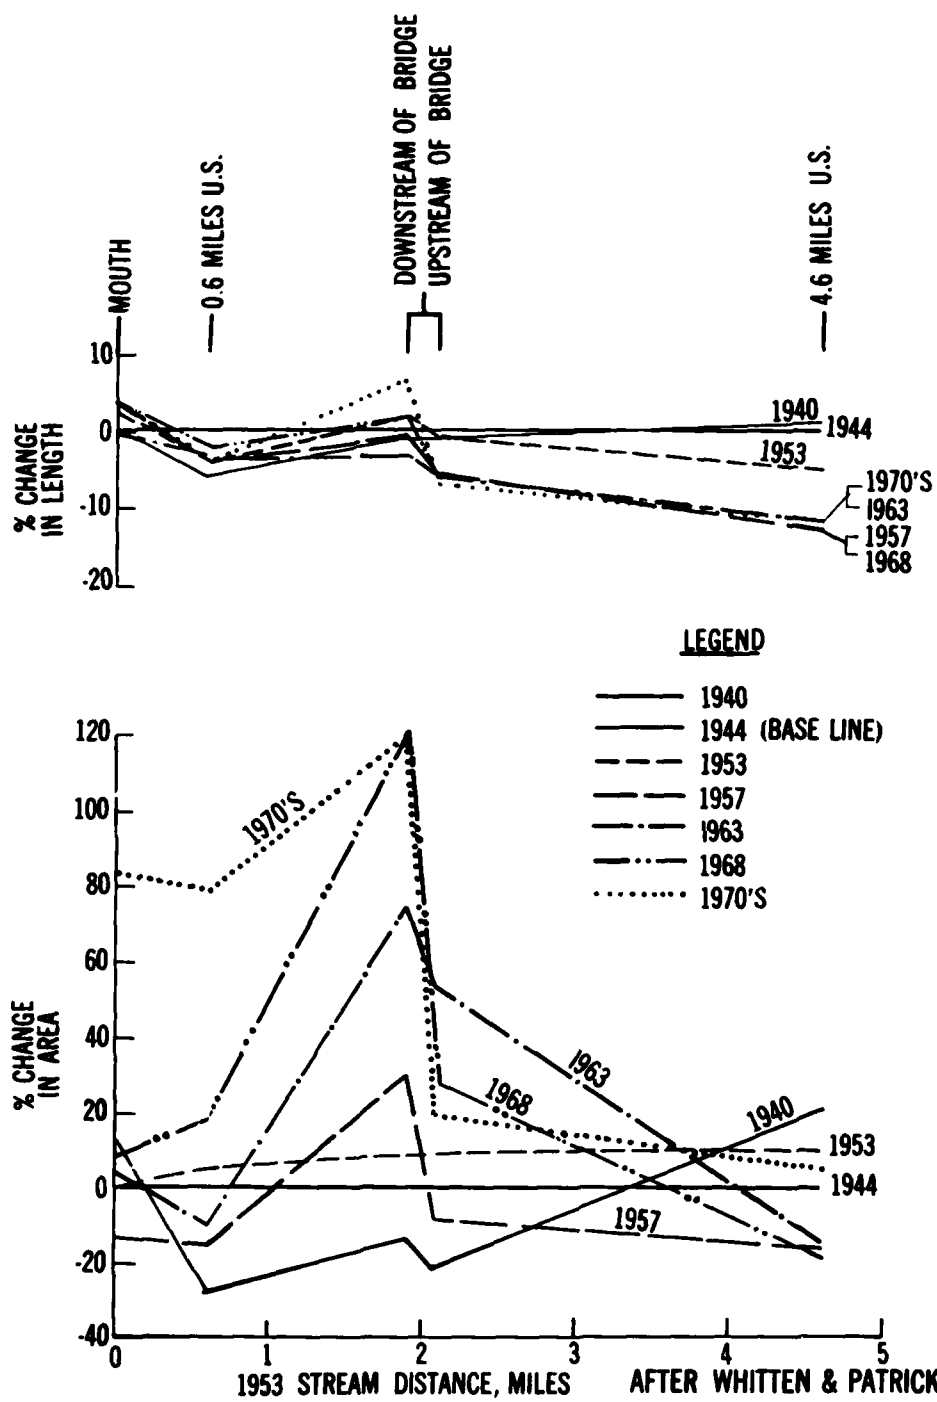
Figure 108. Changes in area and length, Goodwin Creek

Chronological sequences of aerial photos along Goodwin Creek show there has been an increase in channel width since 1940. The area and length changes are shown in Figure 108 (Whitten and Patrick, 1980).

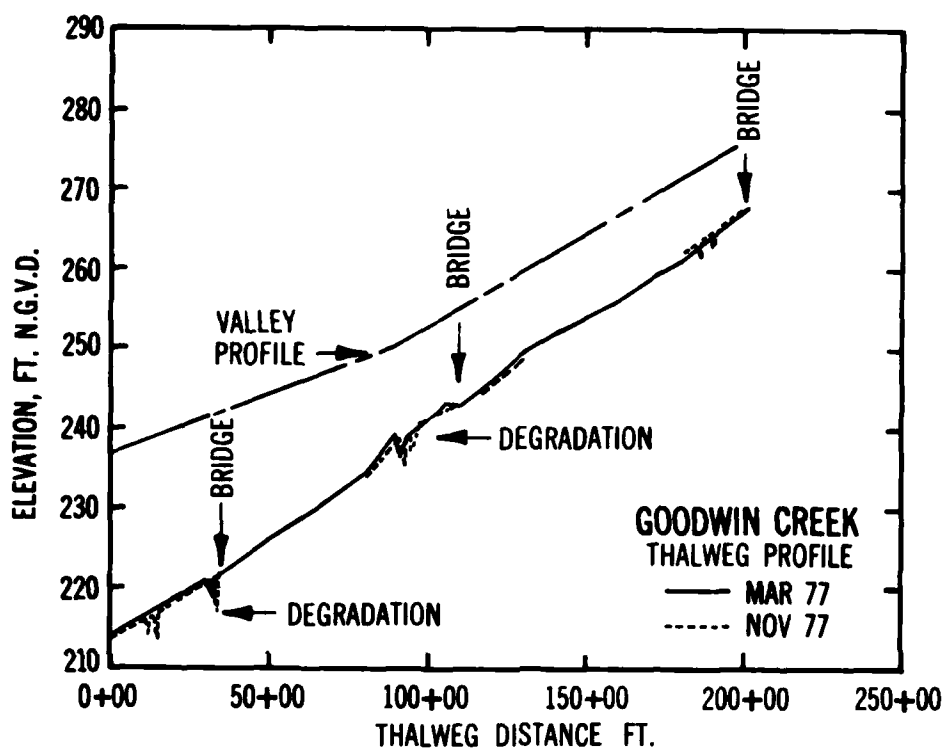
Figure 109. Thalweg profile, Goodwin Creek

Thalweg profiles of March and November, 1977 for Goodwin Creek show degradation continuing along the reach from the mouth to station 49+00 and from 56+00 to 125+00 (Figure 109).

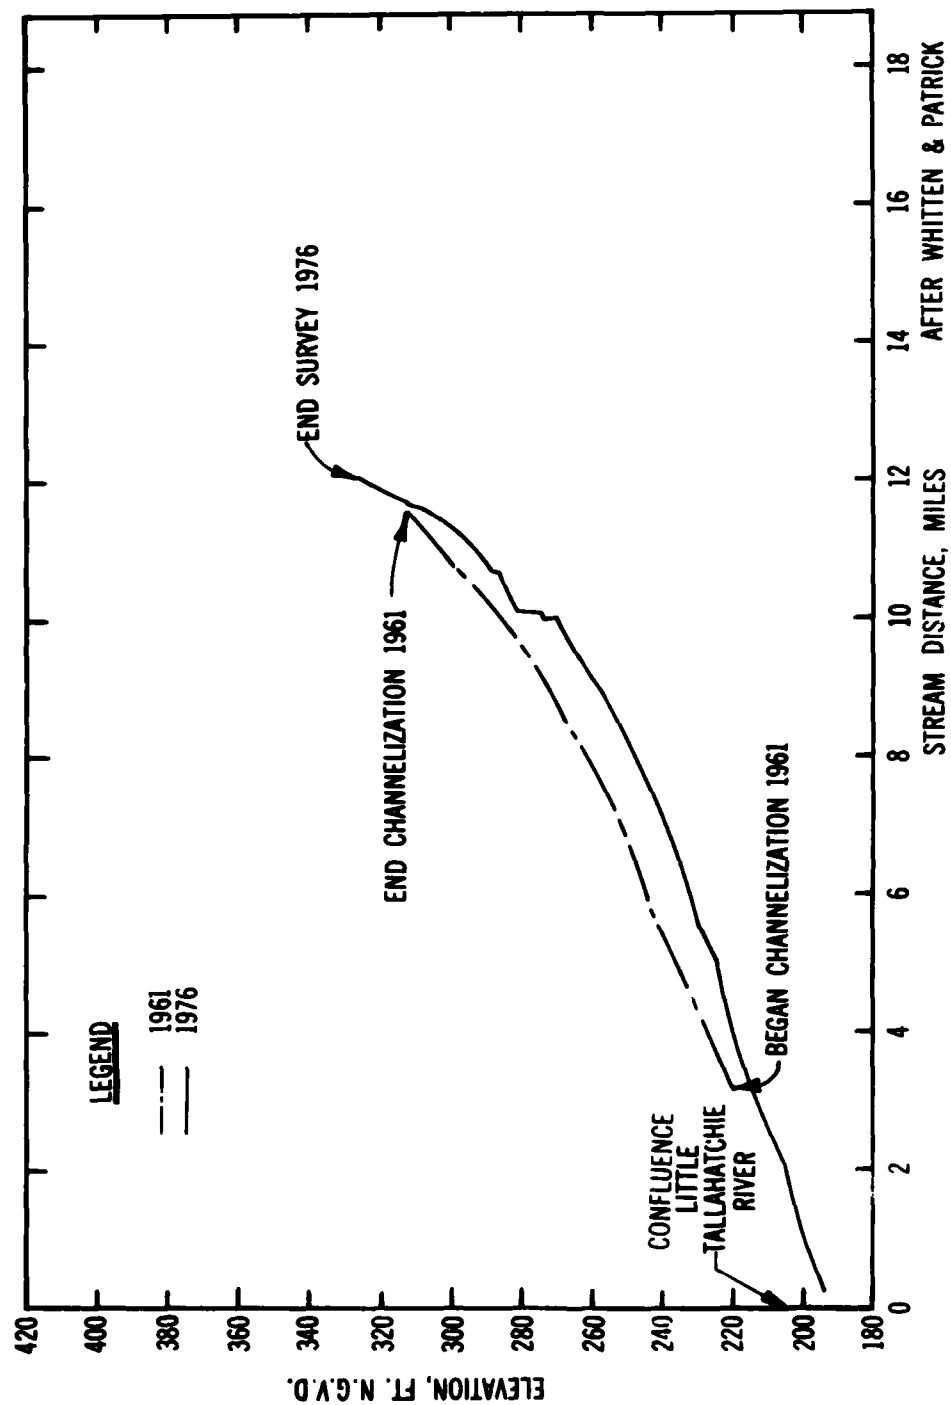
Figure 113. Longitudinal profile of Hotophia Creek

"The 1958-61 channelization shortened the channel length approximately 2.9 miles. The gradient in the channelized stretch was increased from around 7.8 ft/mile to 11.1 ft/mile. A comparison of the 1961 and 1976 longitudinal profiles shows the channel has degraded up to 15 ft (Fig 113). The degradation was

"There is a very prominent knickpoint at point A on the 1976 longitudinal profile (Fig 113). The knickpoint is cutting an erosional resistant clay and has formed a 4- to 5-ft waterfall. The steep, unstable banks resulting from the channel degradation are slumping and/or caving in. The channel directly downstream from the knickpoint is 6 to 10 ft wider than the channel directly upstream from the knickpoint. Cross sections of the 1961 and 1976 channels show there is a downstream increase in width and an upstream increase in depth (Fig 114). The downstream increase in width results from the slumping and caving of the oversteepened banks and from bank erosion caused by the increased sediment load. The banks are also being eroded by piping.

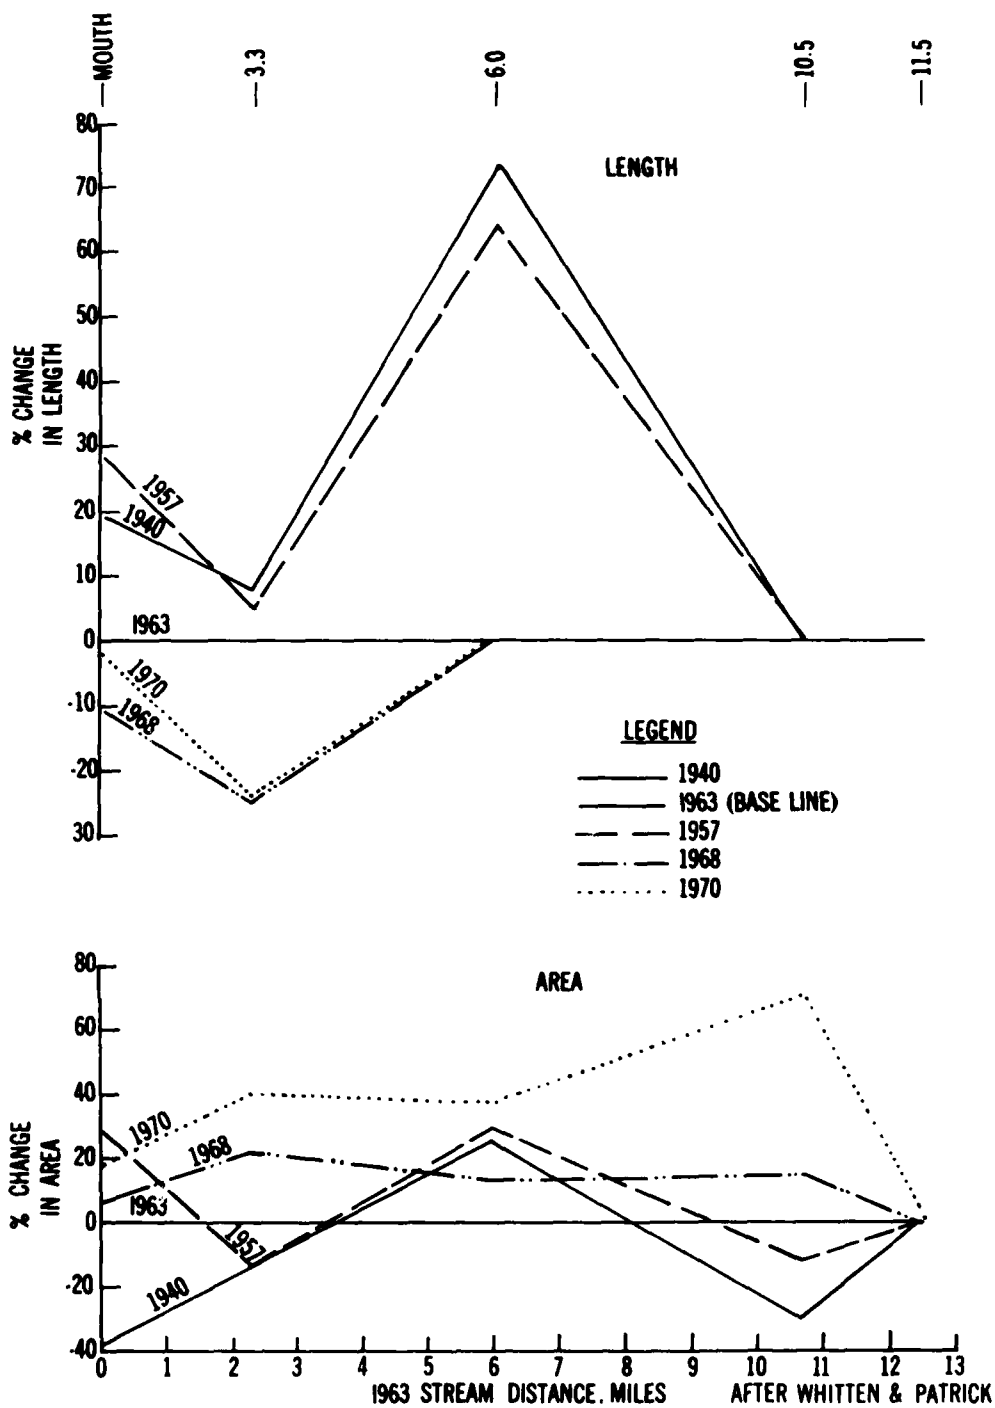
Figure 115. Changes in area and length, Hotophia Creek

"The changes in channel area generally correspond to changes in channel length. Fig 115 shows the changes in channel length and area through time (1940 to 1977). The 1963 data were used as a zero base since channelization (1958-1961) significantly altered the channel morphology. The channel at the mouth and at mile 3.3 was not channelized in 1958-1961. However, the changes in channel morphology of these two locations has been very pronounced. Bank erosion shortened the channel length at both sites. The channel area decreased at the mouth and increased at mile 3.3. The channel at mile 6.0 decreased 74 percent in length and 23 percent in area from 1940 to 1963; but, channel length had not changed since 1963 while the area had increased 39 percent by 1977. The channel at miles 10.5 and 11.5 was channelized prior to 1935, and the channel at mile 10.5 was enlarged in 1958-1961. There has been no change in channel length at either site since 1940; but, the channel areas have increased, especially at mile 10.5. The

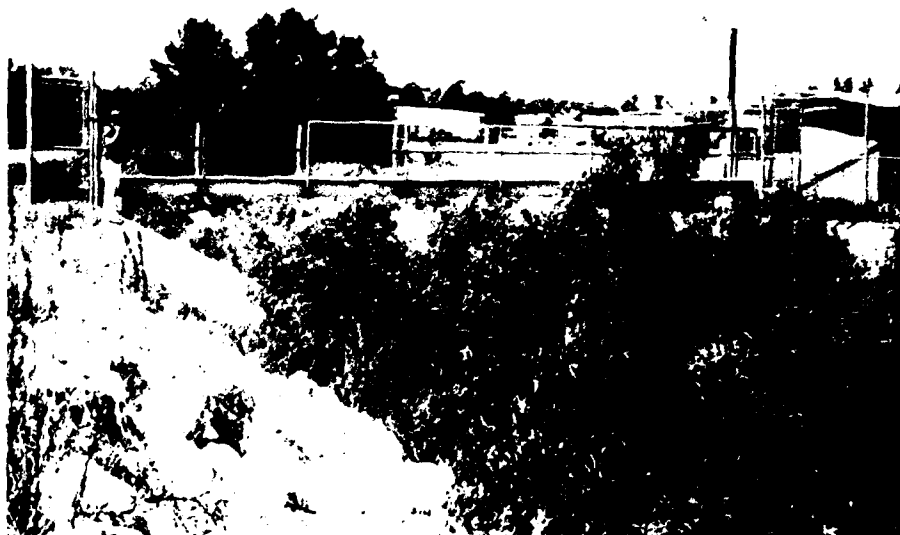
Figure 137. Vegetation in channel, Goodwin Creek

The structures are structurally sound; however, due to periods of below normal rainfall, they have not been subjected to many large runouts. Another problem associated with the low rainfall has been the excessive vegetation growth in the channels above and below the structures. This is illustrated in the photo in Figure 137. Left

Goodwin Creek Site 4  
Vegetation in Channel  
Looking Downstream  
May 1981

Goodwin Creek Site 4  
Vegetation in Channel  
Looking Upstream  
May 1981

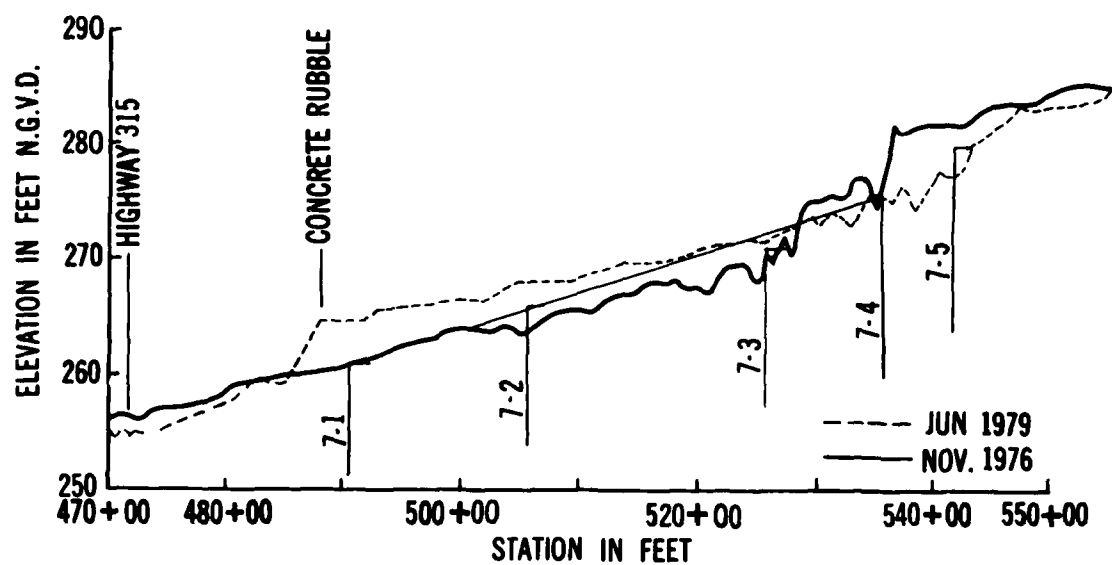
Figure 138. Thalweg profile on Hotophia Creek

A stable grade was selected for the stream from thalweg profile data available and a system of four grade control structures were designated to maintain this grade. A fifth structure was planned upstream to prevent excessive degradation from proceeding to the upstream reaches of the stream. The location and elevations of the structures necessary to produce the desired grade were selected from thalweg profiles. However, when the site surveys were performed, it became apparent that the stream had aggraded several feet in the area of the proposed structures. This aggradation is shown in Figure 138.
